Research Report  
UKTRP-86-25

RUTTING AND LONGITUDINAL CRACKING  
AND TEMPERATURE CRACKING  
A CASE STUDY

(US 23, Greenup County, MP 6.0 to 28.8)

November 1986

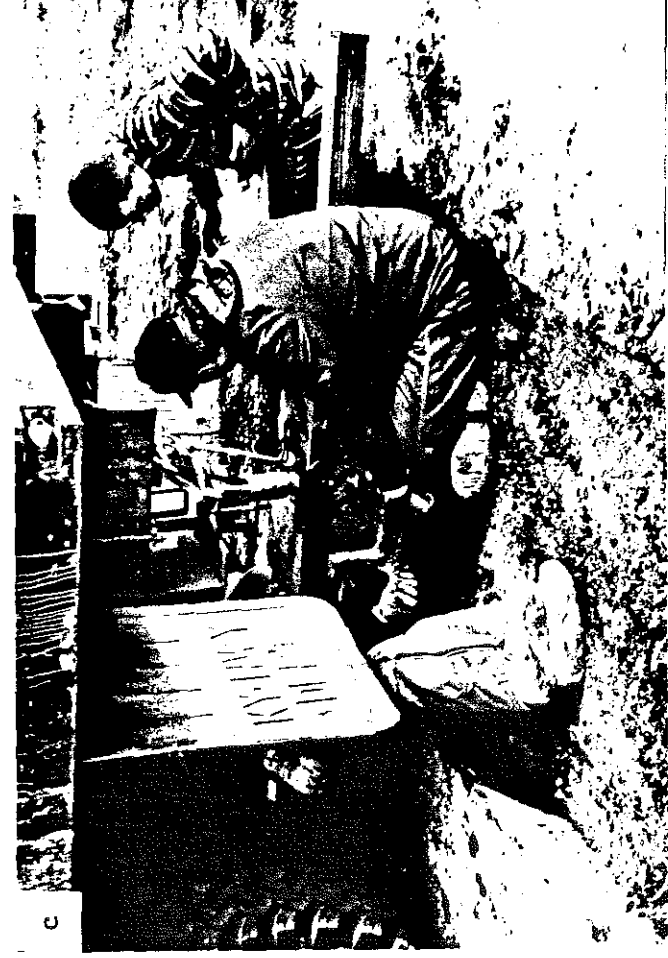
Figure 2. Site 1, MP 14.0, Northbound, Trenched December 12, 1985.

Two sites were trenched on December 12, 1985. The first was at MP 14.0 (Section E) (Figure 2), and the second was at MP 7.3 (Section A) (Figure 3). Both were on the outer northbound lane. Section E contained limestone throughout. Section A was slag. The slag DGA had set (weakly hydraulic) (see Figure 3e).

Wide cracks indicate either permanent shrinkage or in-filling and reclosure. Reclosure on debris would tend to crush material or cause buckling. There was a strong tendency for necking down at joints otherwise well filled. This is illustrated in Figure 2a. A few neat, sharp-edged, narrow cracks were observed. They may have formed much more recently than others.

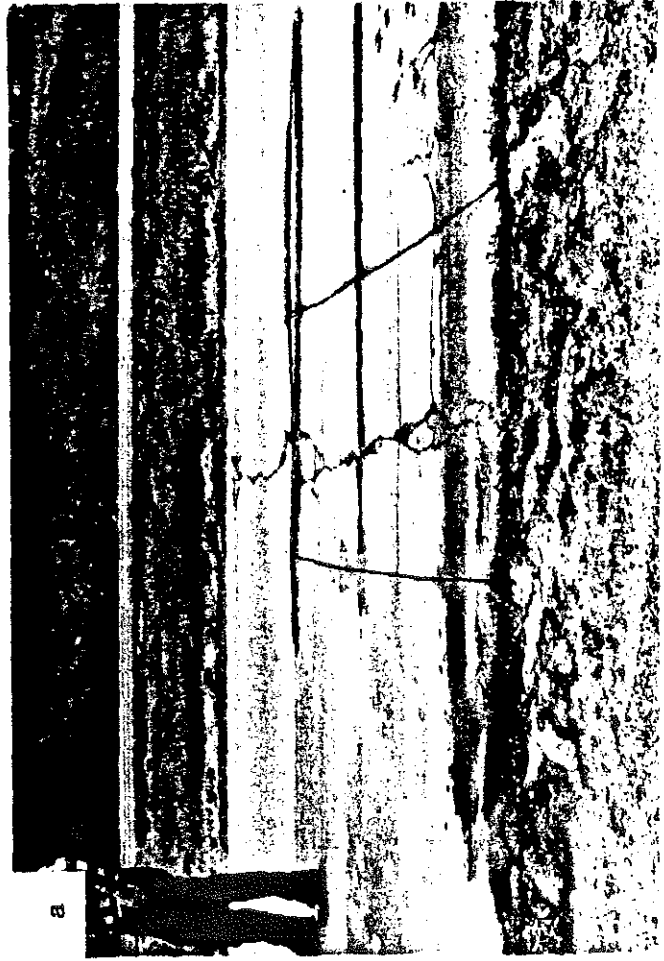
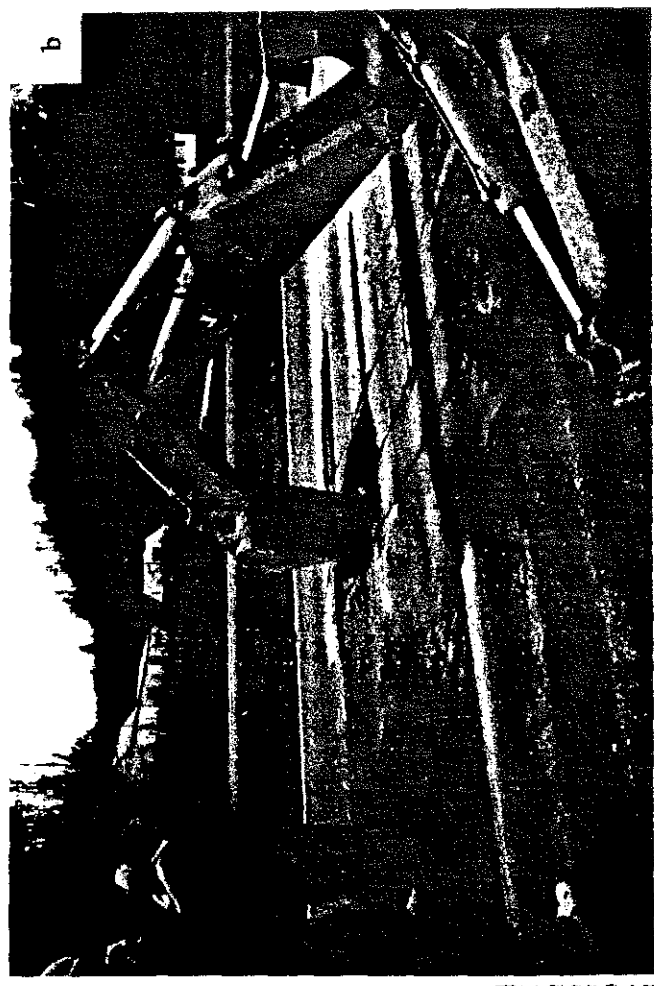
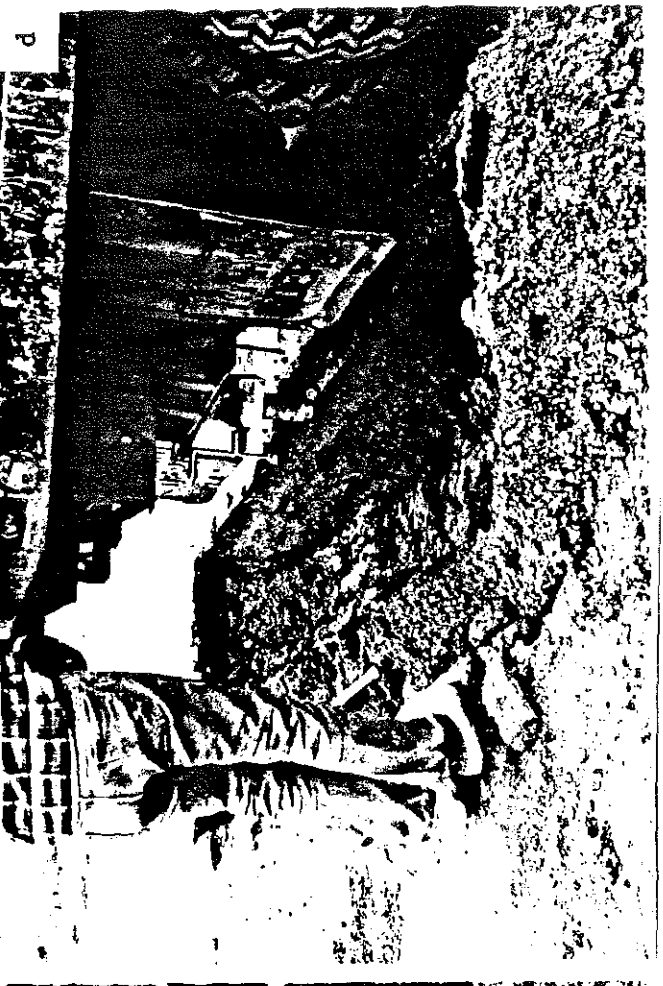
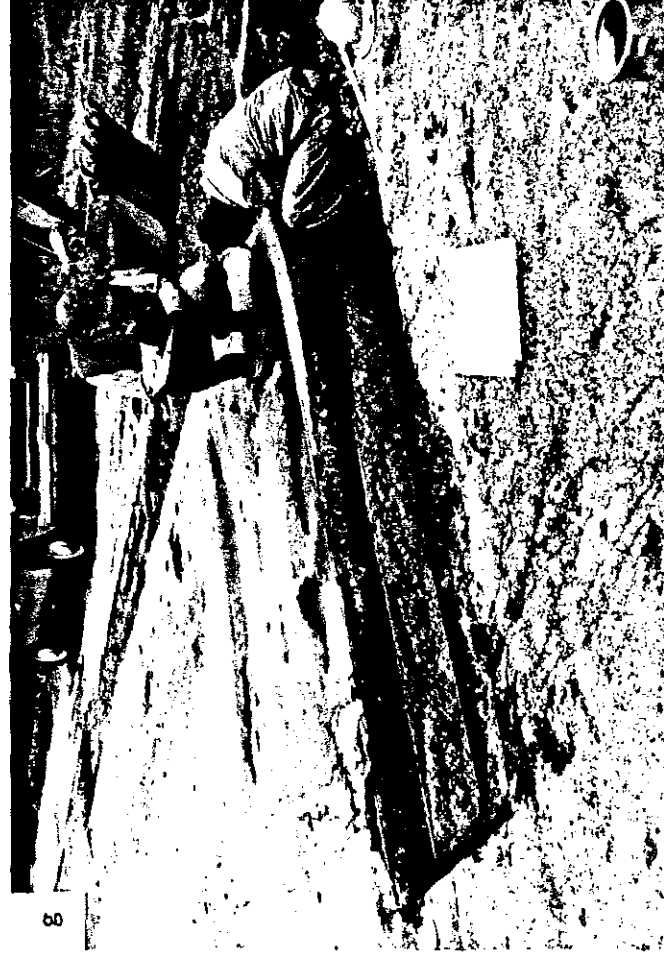
Figure 3. Site 2, MP 7.3, Northbound, Trenched December 12, 1985.

Some witnesses at the trenched sites on US 23 expected to find the transverse cracks at the surface also extending through the DGA base. If a crack had existed in the slag DGA, it would not have escaped notice because the slag base was somewhat monolithic and came up in slabs and chunks. None of the edges showed signs of staining or darkening due to infiltration.

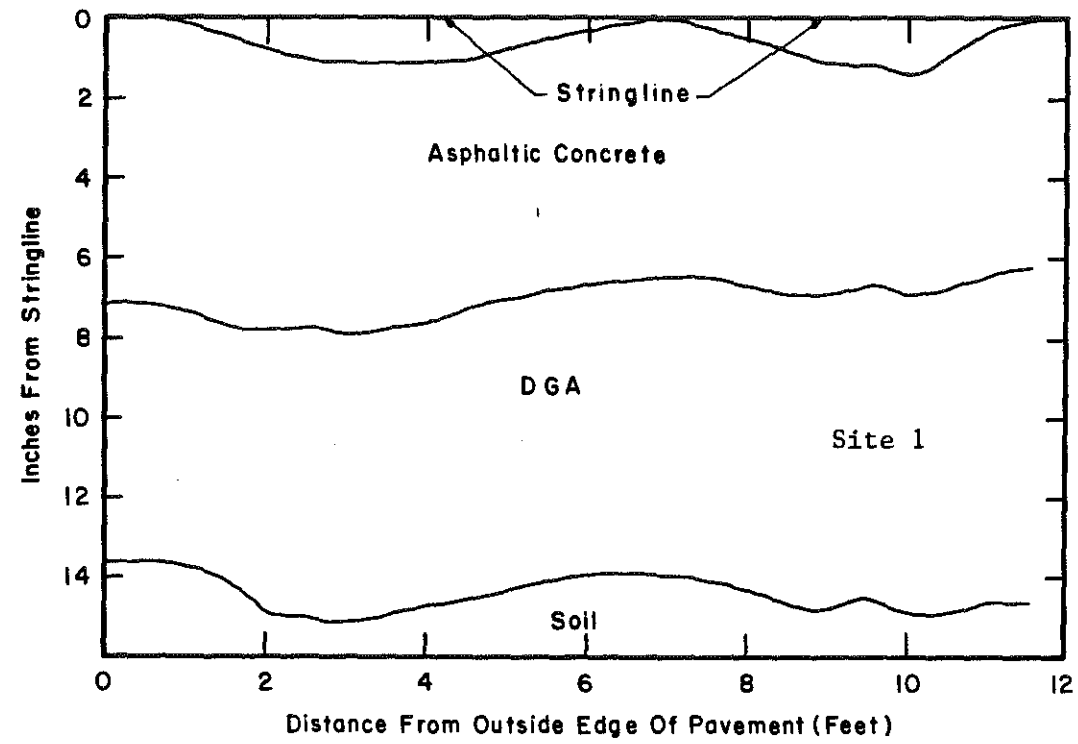
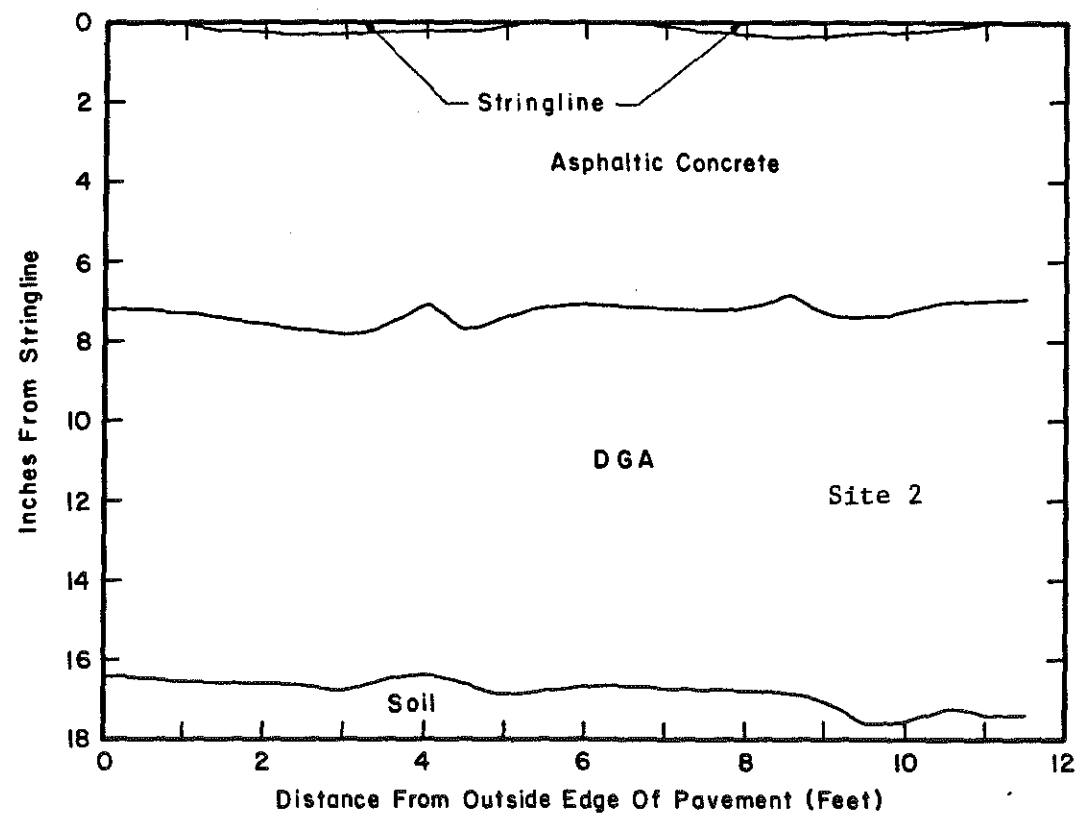
Figure 4. Rutting Measured as Deviations from Stringline: (a) Site 1 and (b) Site 2.

At Sites 1 and 2 (MP 14.0 and 7.3, respectively), rutting measurements were made at the surface, at the asphalt-dense-graded aggregate interface, and at the dense-graded aggregate-subgrade interface. Offsets from stringlines were used to determine rut depths. Figure 4a shows the measured rutting at Site 1. Surface rutting in the inside wheel track was 1.4 inches. The asphalt layers in the inside wheel track had thinned to 5.5 inches. Rutting in the subgrade averaged approximately 1.0 inch.

At Site 2, surface rutting was less than 0.5 inch. However, the asphaltic concrete-dense-graded aggregate interface had rutted 0.8 inch in the outside wheel track, and the subgrade had rutted 0.6 inch in the inside wheel track. Figure 4b shows the measured rutting at Site 2.

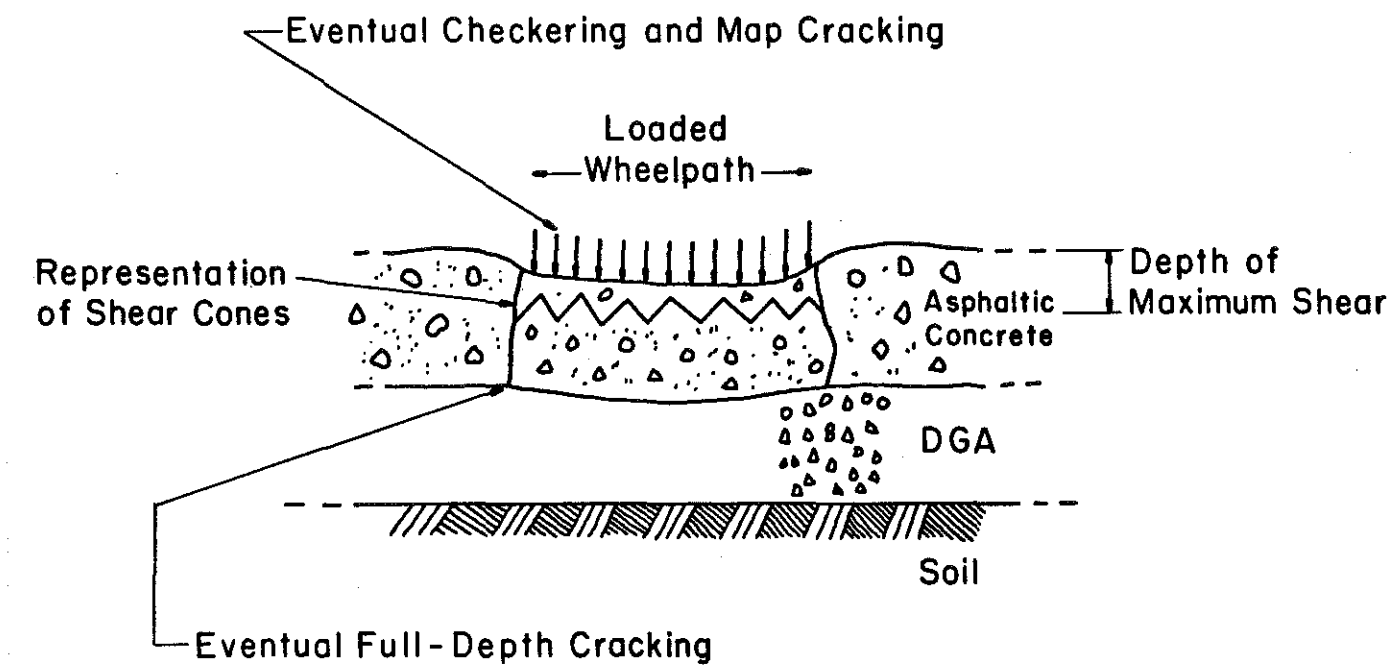
depth of maximum shear would be 5 inches. Punching shear may suffice to explain longitudinal cracking at the edges of the wheelpaths. Maximum shear may explain eventual checkering and map cracking within the wheelpaths. Kneading shear in the wheelpaths together with punching shear at the edges progresses little by little. These concepts are illustrated diagrammatically in Figure 6. A crushed rock base may be as strong after deformation as it was before deformation, and the foundation soil may not be critically weakened until slip planes develop or swelling due to water infiltration occurs. An example of early failure exhibiting a longitudinal crack pattern is shown in Figure 7. There, failure occurred within a few months of service, it was attributed to gelled clay in the foundation (site was trenched and evaluated). Subsequent overlayment hid and adequately bridged over the short section involved. Heavy hauling may have abated also.

Figure 6. Schematic Diagram Illustrating Conceptual Modes of Shear Failure Accompanying Rutting. Punching shear occurs across the wheelpath. Kneading shear occurs within the wheelpath and eventually leads to checkering and blocking out.

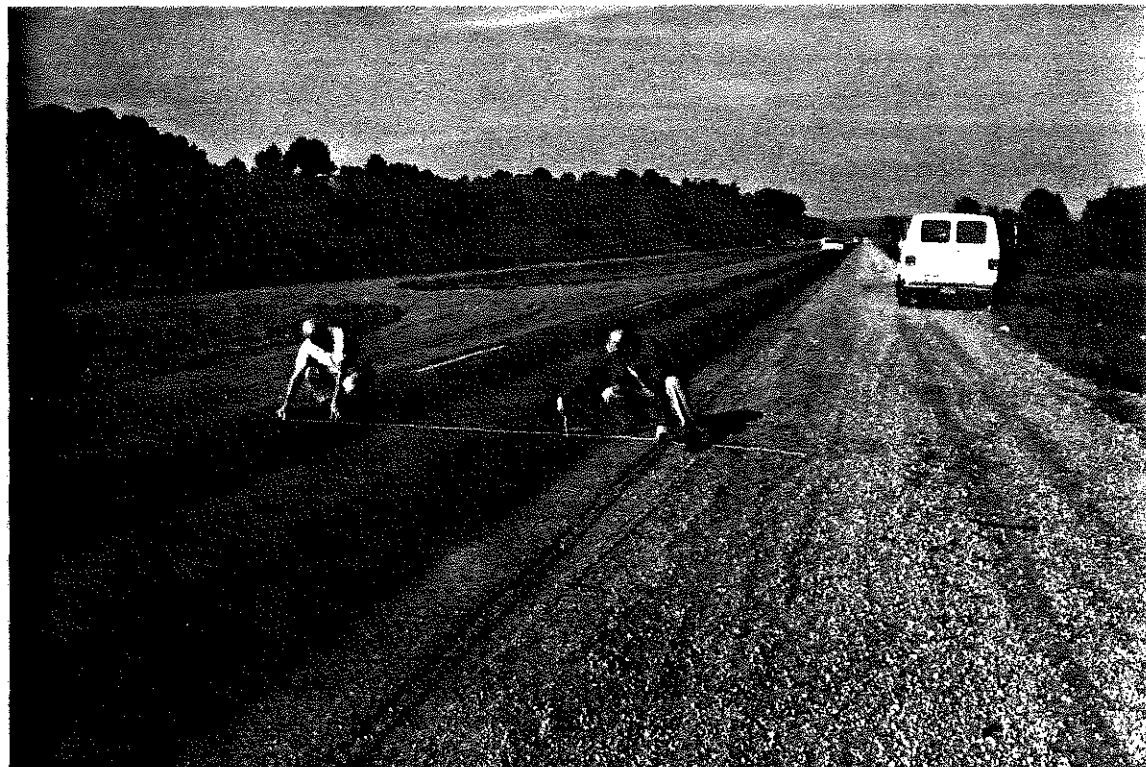
Rutting: Section Chip-Sealed Previously; Depth  
Nominally 1.5 inches; Inner Lane not Rutted;  
Facing South Shore (10-10-85)

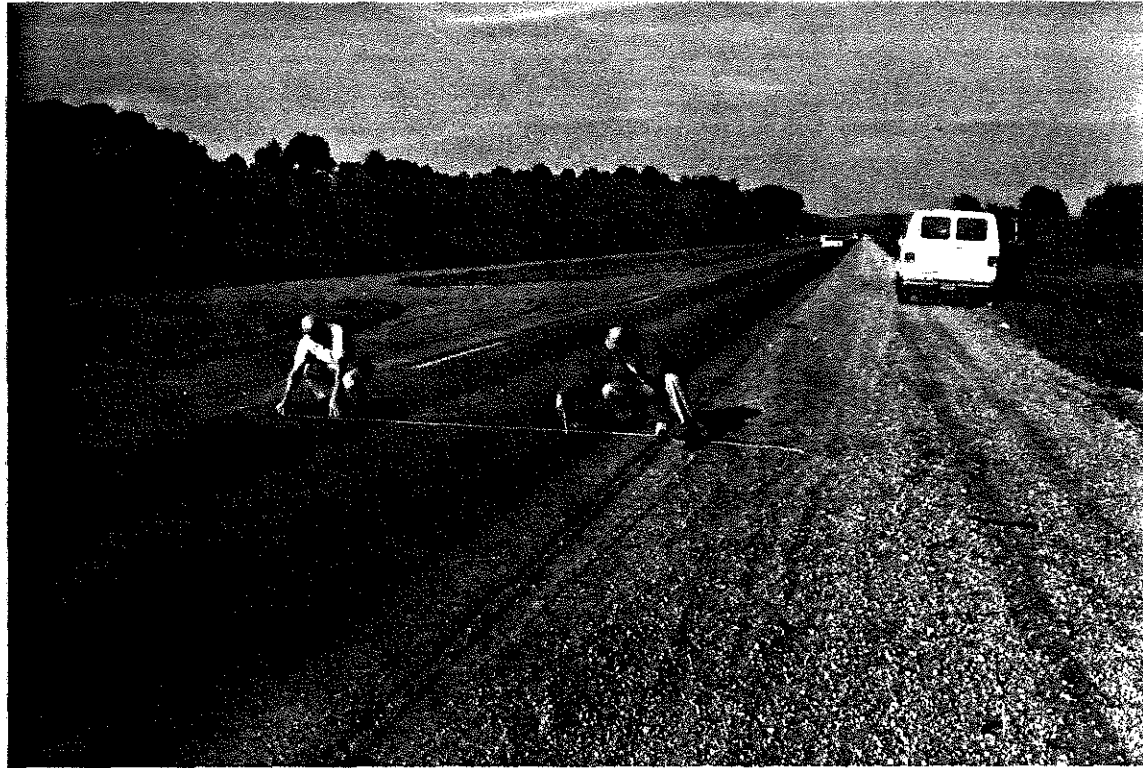
Rutting: Section Chip-Sealed Previously; Depth  
Nominally 1.5 inches; Inner Lane not Rutted;  
Facing South Shore (10-10-85)

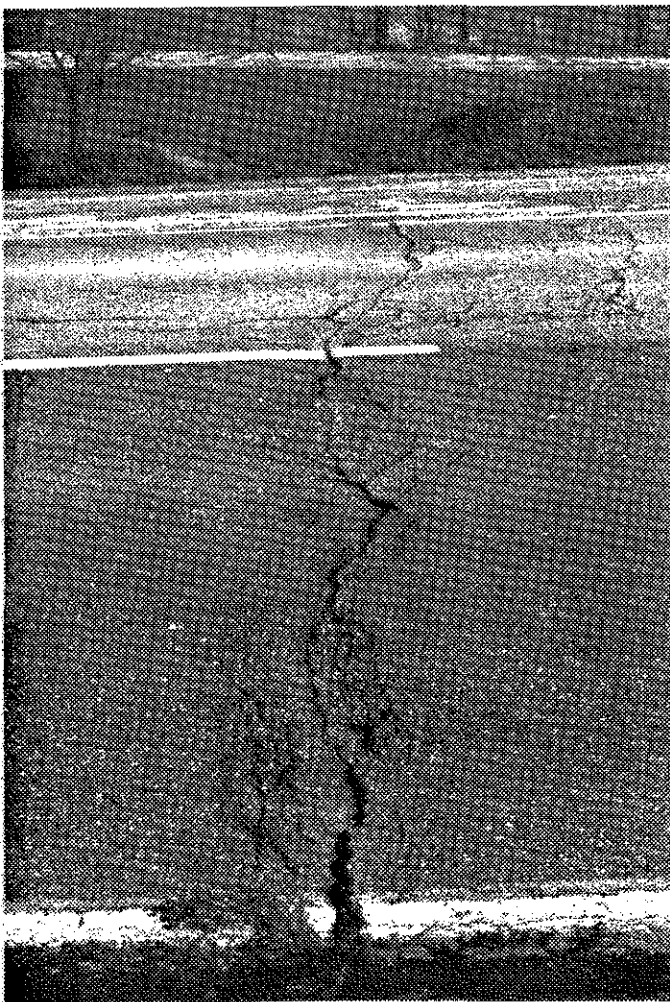
Section D - SB lanes at 991 ft.

END SURVEY  
1000  
photo # 869  
991'  
CAN SEE SUBBASE  
THRU CRACK -  
CRACK R'D ACROSS  
TWO LANES  
975

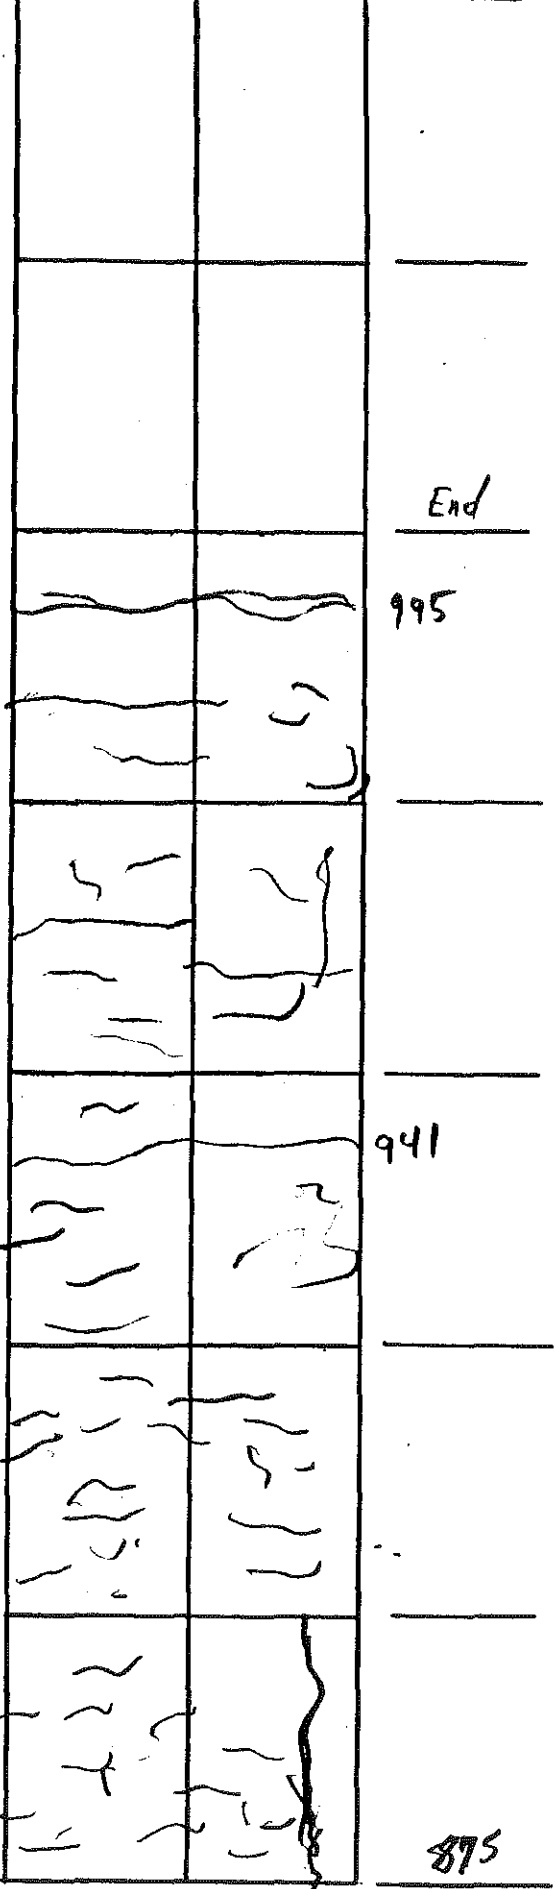
NORTHBOUND LANES

NOTE: A LOT OF ALLIGATOR CRACKING IN  
THE WHEEL PATHS, TRANSVERSE CRACKS  
NOT THAT SEVERE.

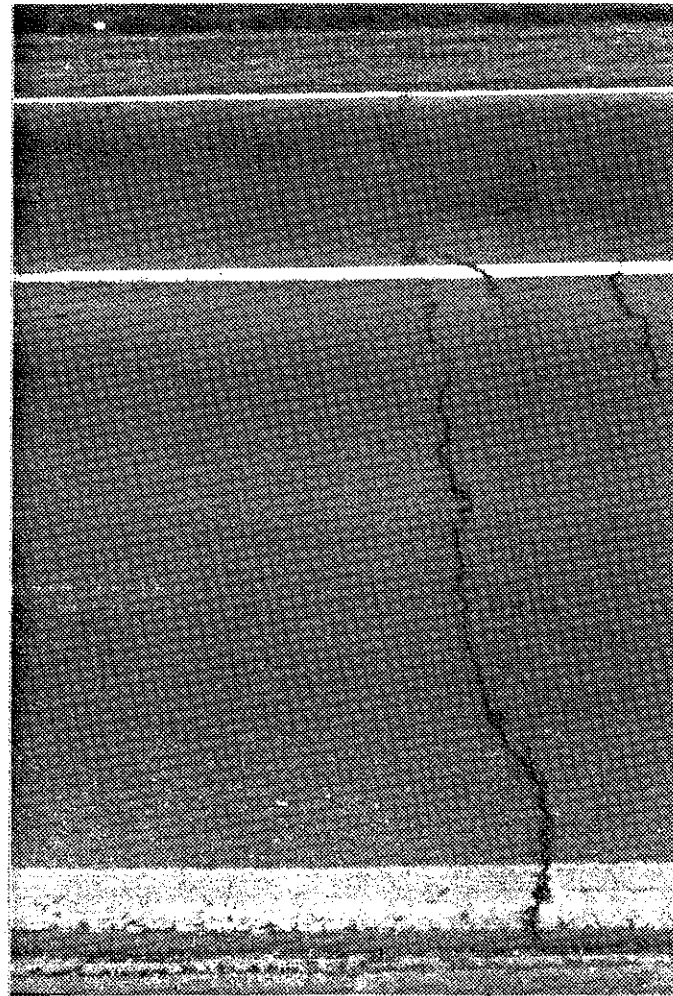
Section J - SB lanes at 451 ft.

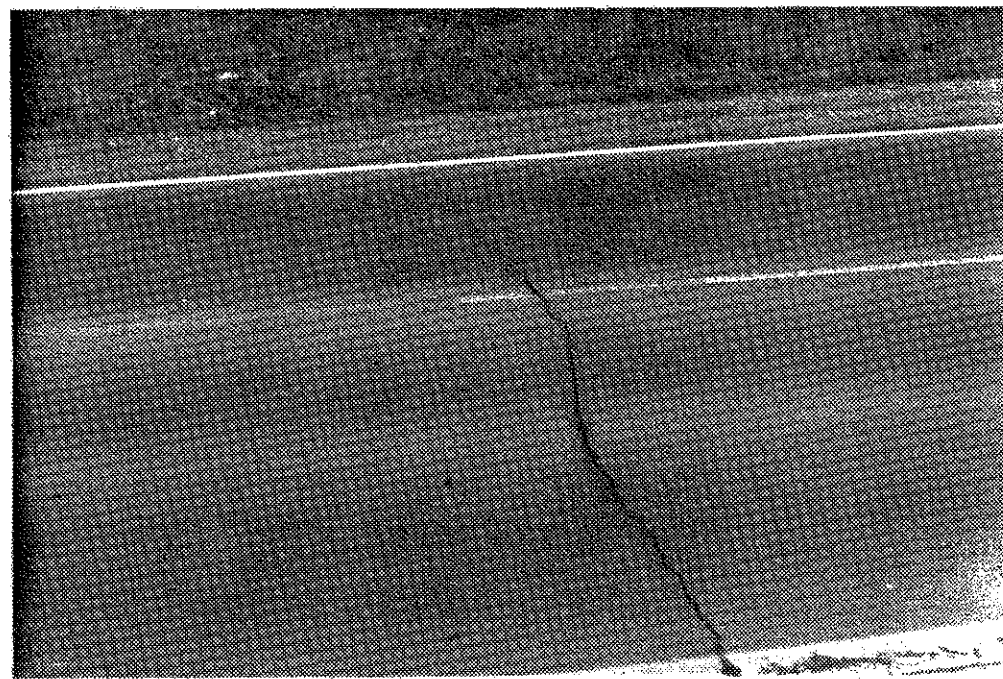
Section J - SB lanes at 920 ft.
